## Annual Inspection

Badby Parish Council

Badby Playing Field

Chapel Lane, Badby, NN11 3AQ

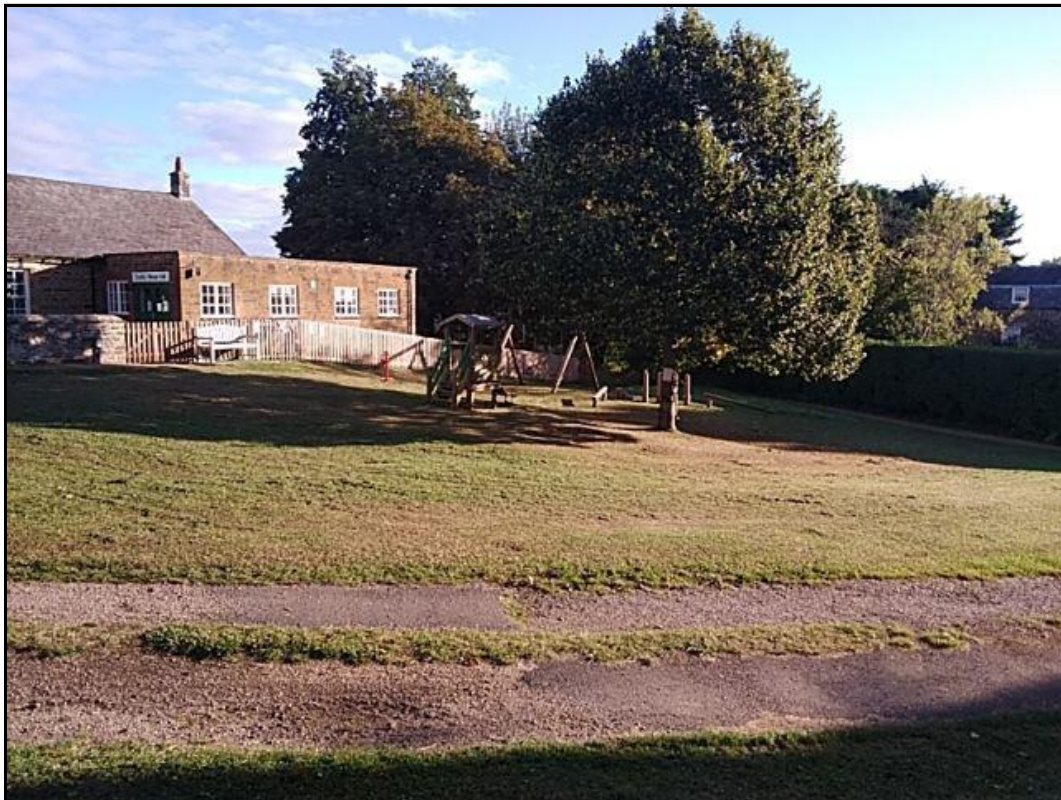
**Location:**

The site is located in an area of public open space and is not directly overlooked by any properties in the local community.

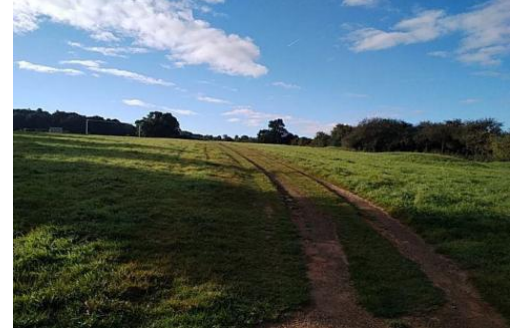
**Item:** Site General  
**Manufacturer:** Owner/Operator  
**Surface Type:** N/A  
**Item Quantity:** 1  
**Equipment Compliance:** N/A  
**Surface Area Compliance:** N/A

There are a number of molehills within the area and these may present unforeseen hazards for users - Remove moles by appropriate means, reinstate surfaces to level and maintain the area

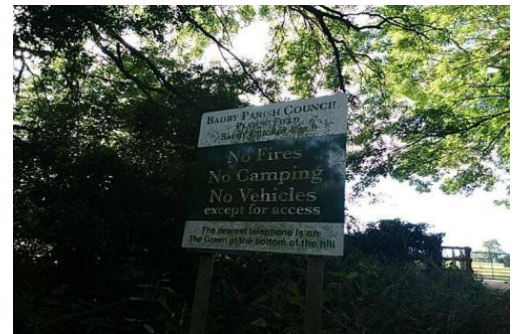
**Item:** Sign  
**Manufacturer:** Owner/Operator  
**Surface Type:** N/A  
**Item Quantity:** 1  
**Equipment Compliance:** N/A  
**Surface Area Compliance:** N/A

BS EN 1176 Part 7 recommends that signage shall include emergency contact details and contact details of owner / operator for reporting maintenance issues - Provide additional information

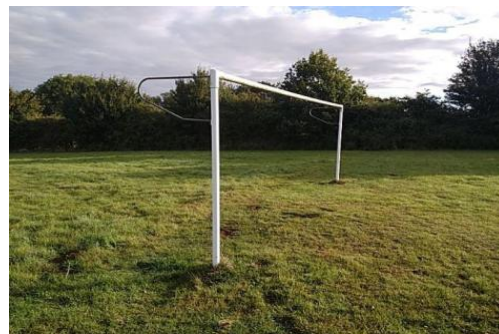
**Item:** Football Goal  
**Manufacturer:** Not Identified  
**Surface Type:** Grass  
**Item Quantity:** 1  
**Equipment Compliance:** N/A  
**Surface Area Compliance:** N/A  
**Life Expectancy:** 5 -10 Years  
**Total Findings:** 4

There are missing and/or loose crossbar fixings on the goal  
- Replace and secure all loose fixings

The item is slightly loose in its foundations - Monitor for any further deterioration and repair as required

A number of fixing(s) have worked loose - Secure all loose fixings

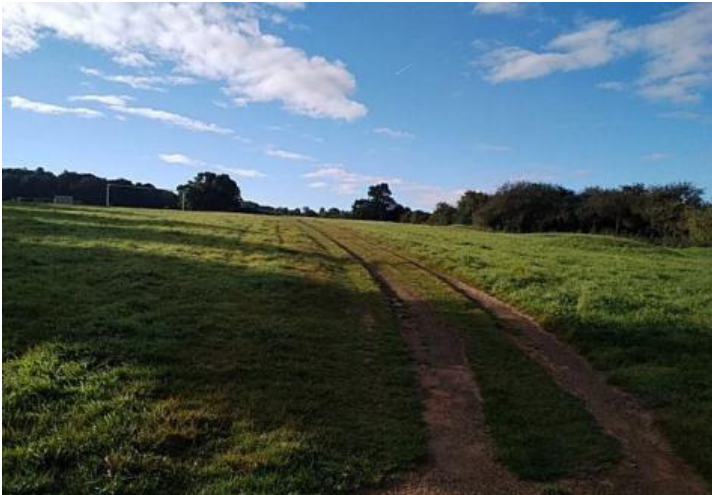
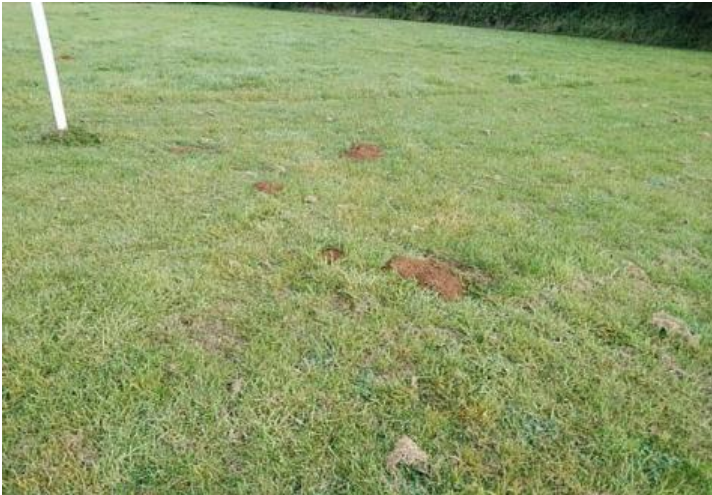
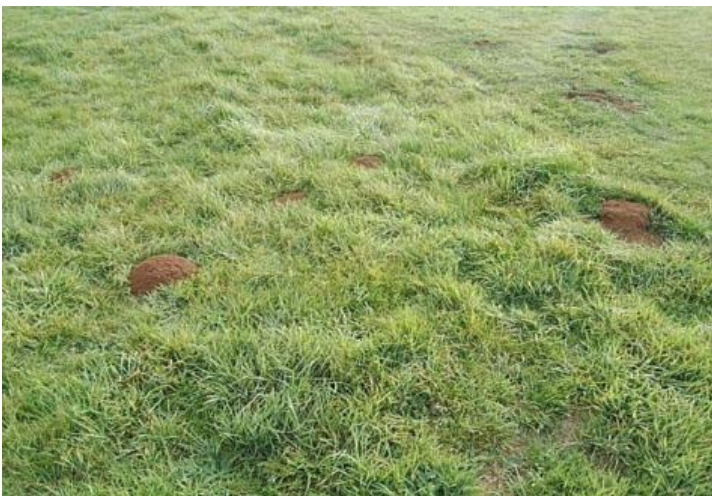
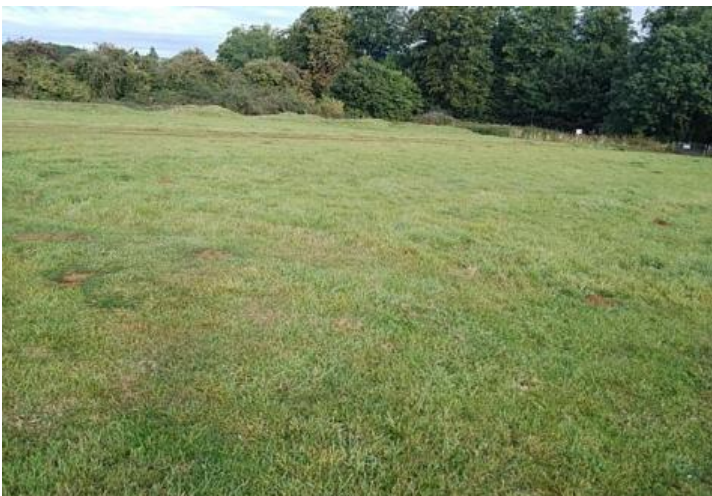
| 8 - Low Risk (Finding 1) | | | |

| 8 - Low Risk (Finding 1) | | | |
|---|---|---|---|
| <b>Finding:</b> There are a number of molehills within the area and these may present unforeseen hazards for users | | <b>Action:</b> Remove moles by appropriate means, reinstate surfaces to level and maintain the area | |

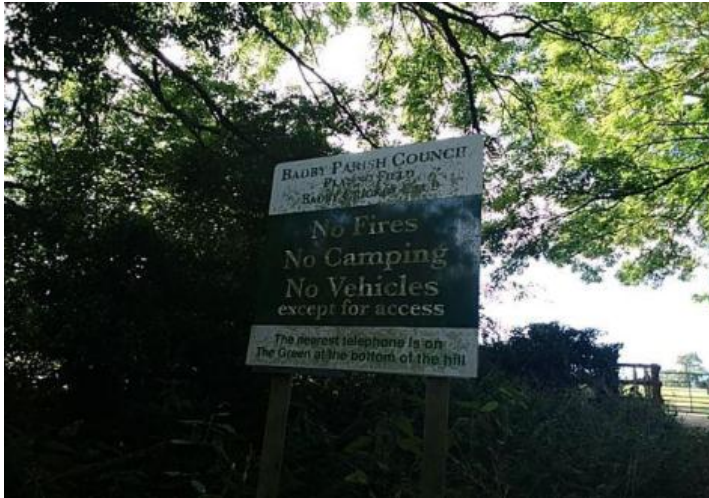
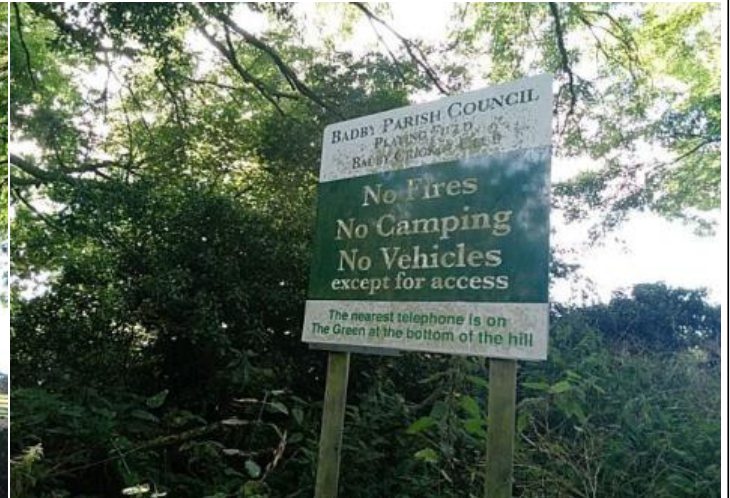
**i 5 - Very Low Risk (Finding 1)**

**Finding:** BS EN 1176 Part 7 recommends that signage shall include emergency contact details and contact details of owner / operator for reporting maintenance issues

**Action:** Provide additional information

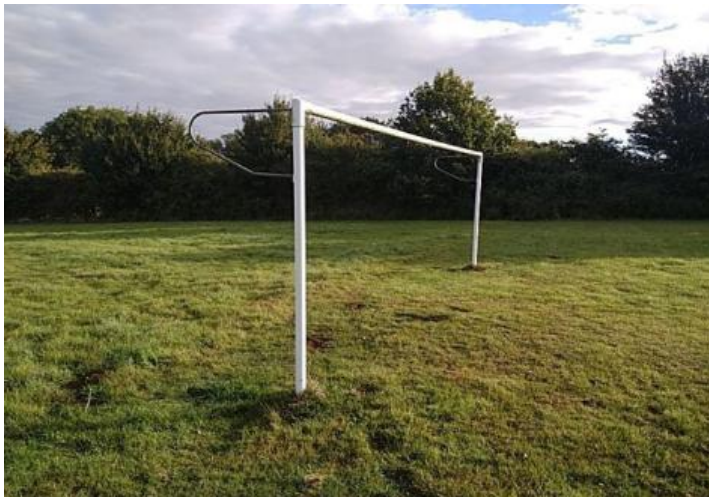
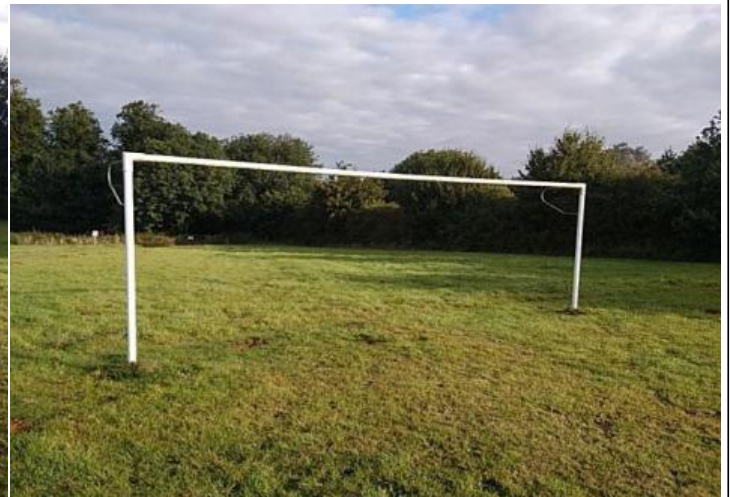
**i 0 - Risk Assessment not Undertaken (Finding 1)**

**Finding:** NB: We have undertaken a maintenance inspection only of the football goal(s); full load testing falls outside the scope of our inspection.

**Action:** Implement load testing as required

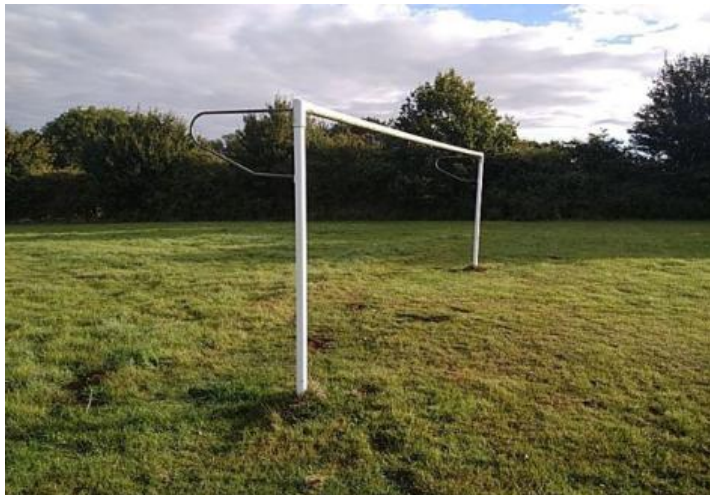
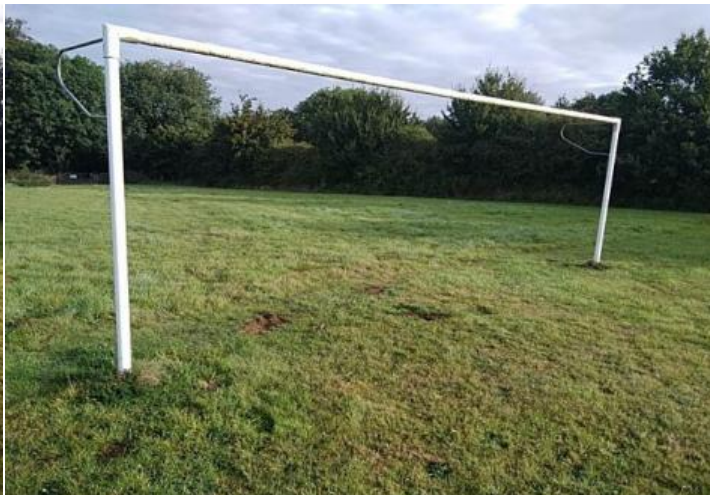
**i** 6 - Low Risk (Finding 2)

**Finding:** The item is slightly loose in its foundations

**Action:** Monitor for any further deterioration and repair as required

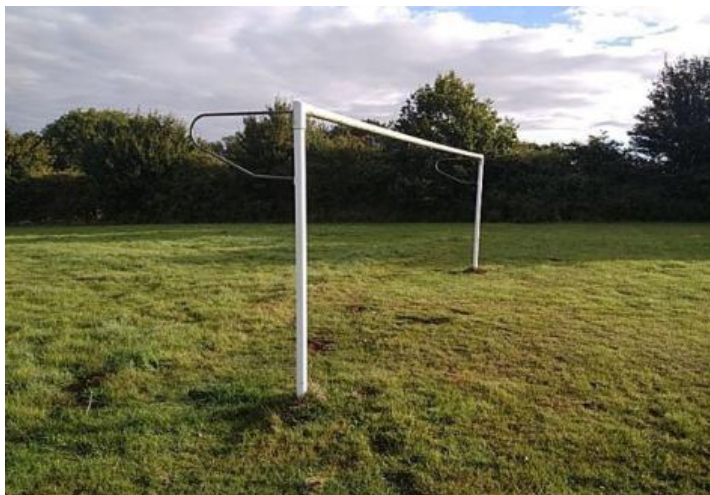
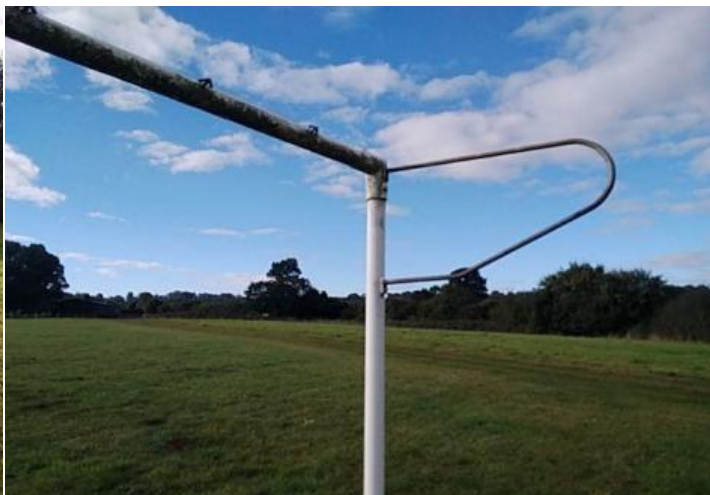
**i** 10 - Low Risk (Finding 3)

**Finding:** There are missing and/or loose crossbar fixings on the goal

**Action:** Replace and secure all loose fixings

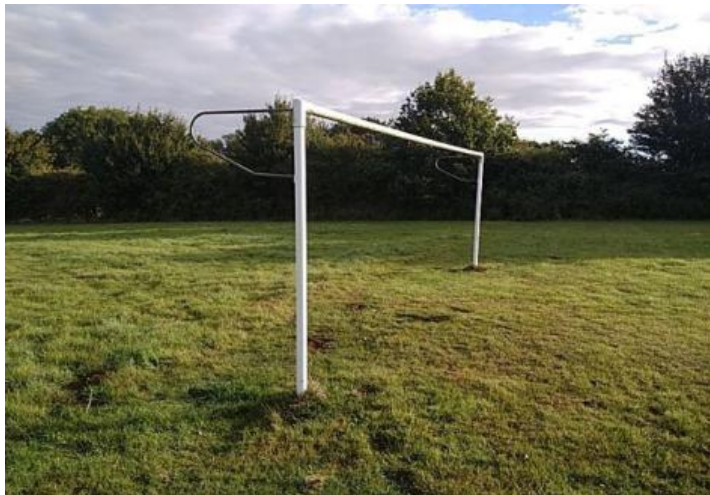
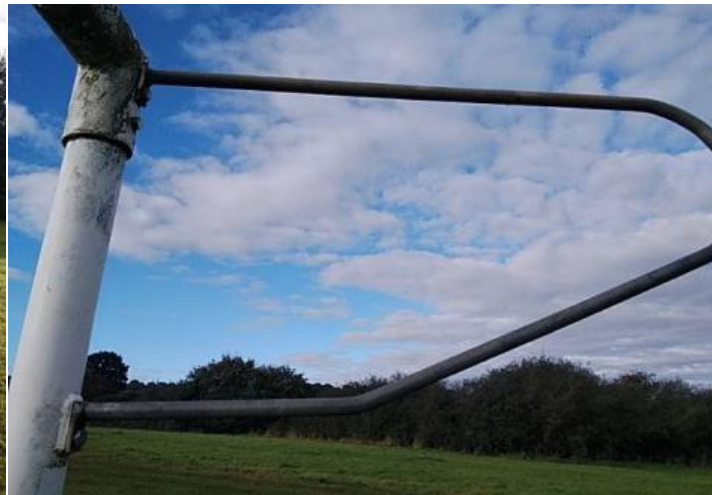
**i** 6 - Low Risk (Finding 4)

**Finding:** A number of fixing(s) have worked loose

**Action:** Secure all loose fixings

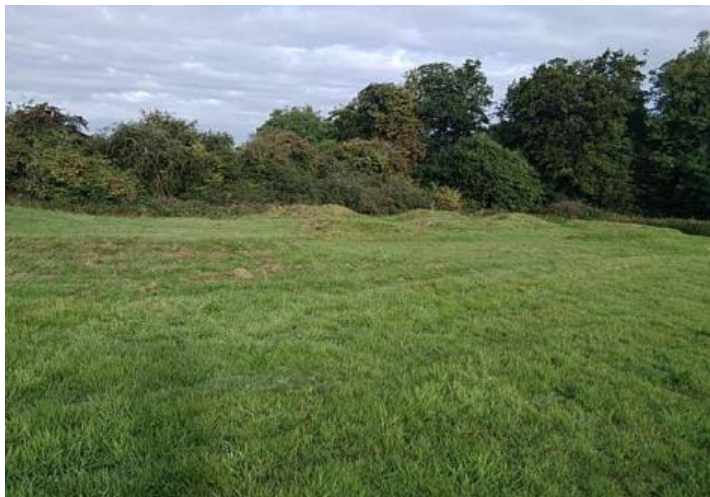
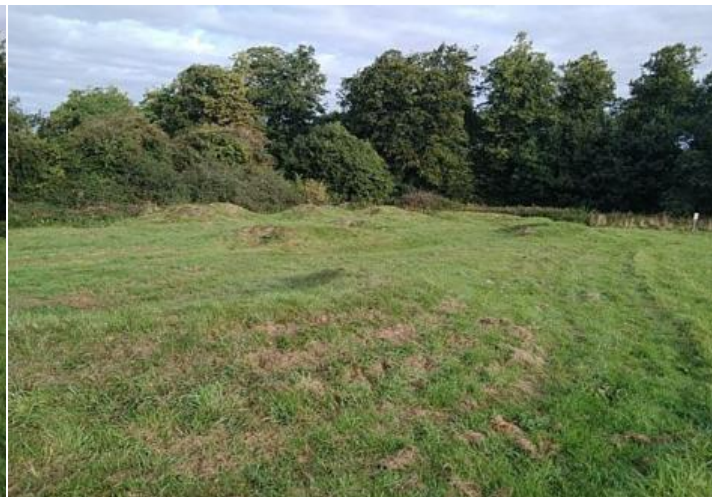
**i** 10 - Low Risk (Finding 1)

**Finding:** BMX tracks are not currently covered by any British or European Standard; comments made in the report are based on the application of our knowledge and understanding of the Wheeled Sports Standard (BS EN 14974) and their maintenance and the area has been risk assessed accordingly

**Action:** Monitor use and review risk assessment regularly

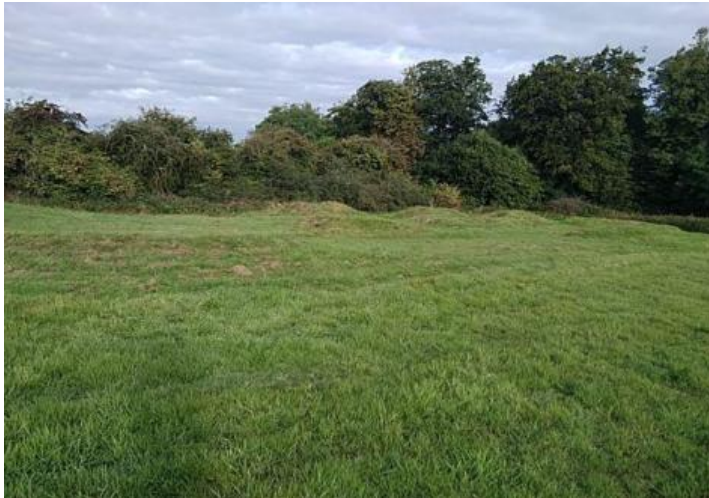
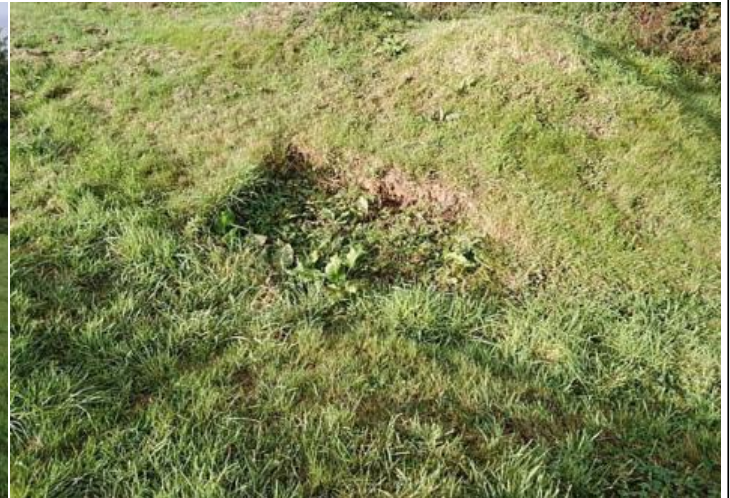
**i** 8 - Low Risk (Finding 2)

**Finding:** There are holes in surface that may have been created purposely by users.

**Action:** Infill to provide a sound reasonably level surface.

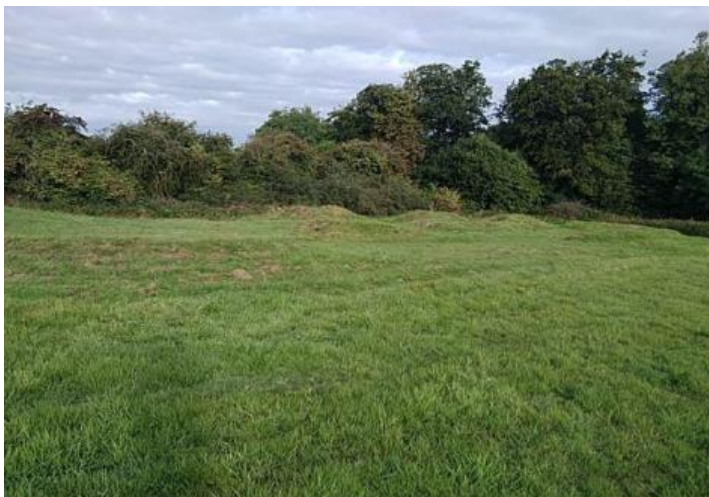
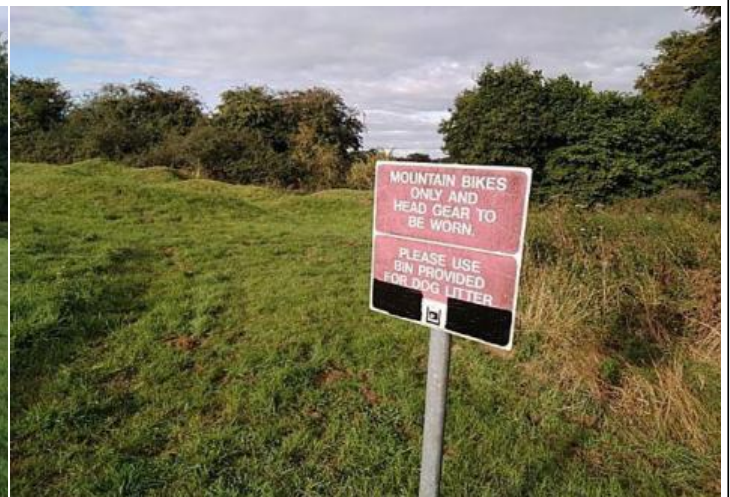
**i** 5 - Very Low Risk (Finding 3)

**Finding:** Signage of the wheeled sports area should be provided as recommended in BS EN 14974; this will include, but not exclusively, the use of the area, a recommendation to wear protective equipment, emergency contact details etc.

**Action:** Provide signage as recommended by BS EN 14974 for wheeled sports areas
